# Counterfeit Electronics Optical Microscopy

## Navid Asadi

#### Physical Inspection and AttacKs on ElectronicS (PHIKS)

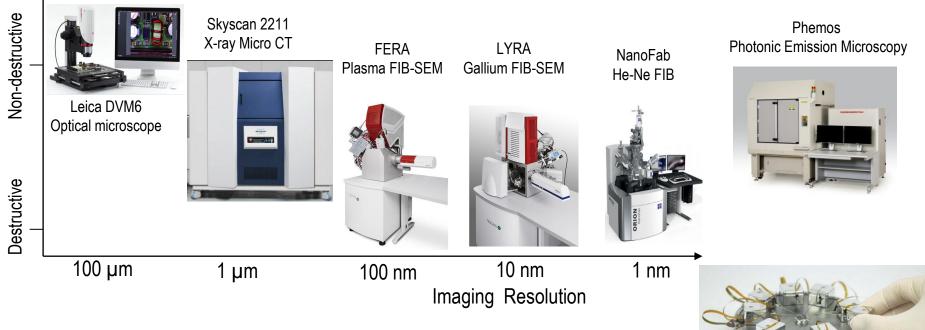
### **Microscopy and FA Tools**

- Imaging and debugging tools are developed for fault analysis.
- Fast advancement in FIB/SEM imaging
- Advancement in photonic emission microscopy, LVS, IR analysis
- Development in micro and nano probing, EBIC, EBAC

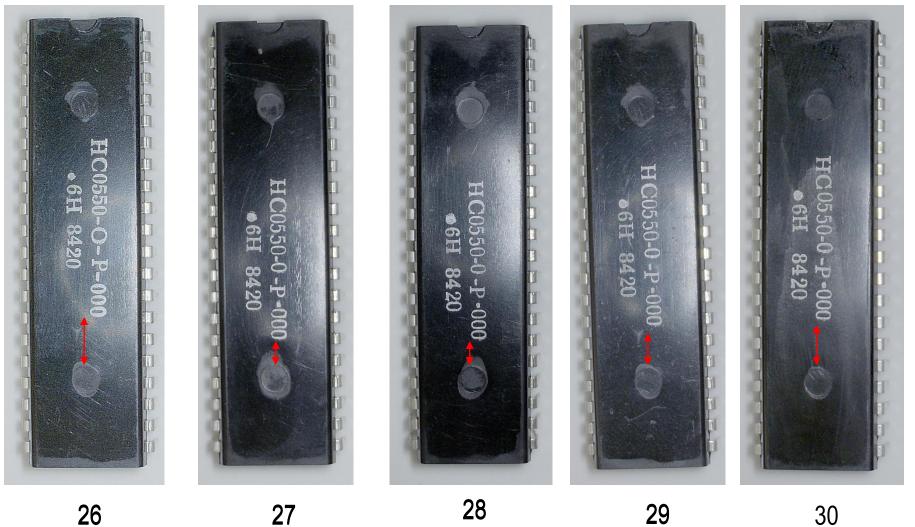
### **Optical Inspection**

Different marking location

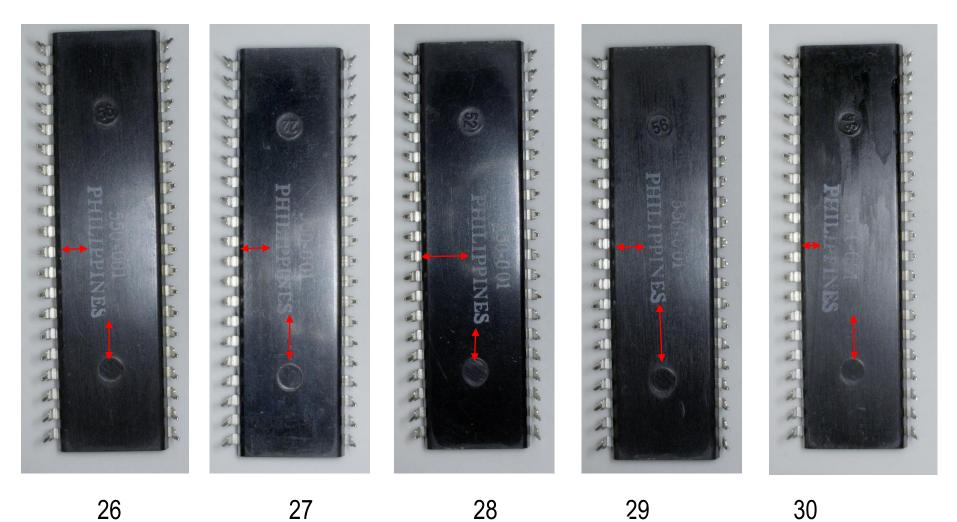
#### **Back Surface**

Different marking location

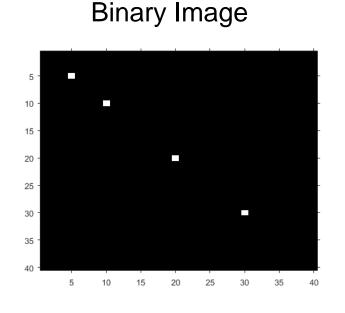
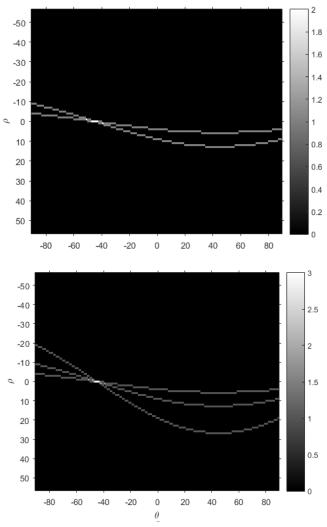
#### Accumulator

- Each white pixel in a binary image "votes" for a family of lines in an accumulator matrix
- Given a set of angles  $\theta = \{-89^\circ, ..., 90^\circ\}$  on some interval and a pixel  $(x_0, y_0)$ :
  - Can define the family of lines that pass through  $(x_0, y_0)$  as:
  - $r = x_0 \cos\theta + y_0 \sin\theta$ 
    - Each pair  $(r, \Theta)$  in the accumulator matrix is incremented by 1

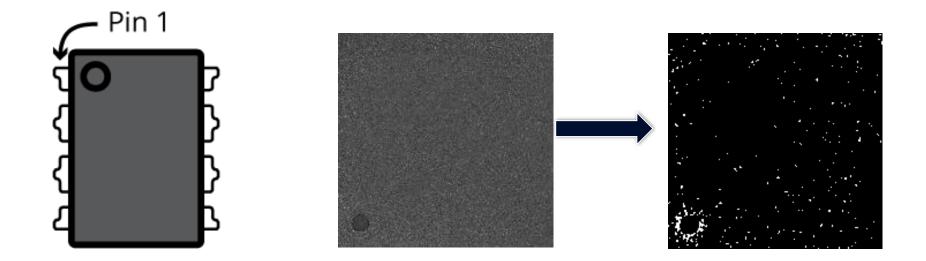
### Preprocessing: Confounding Element Removal

- Problem: Text, Logos, and orientation markers can create false Hough Line peaks
- Here, we assume text has already been removed

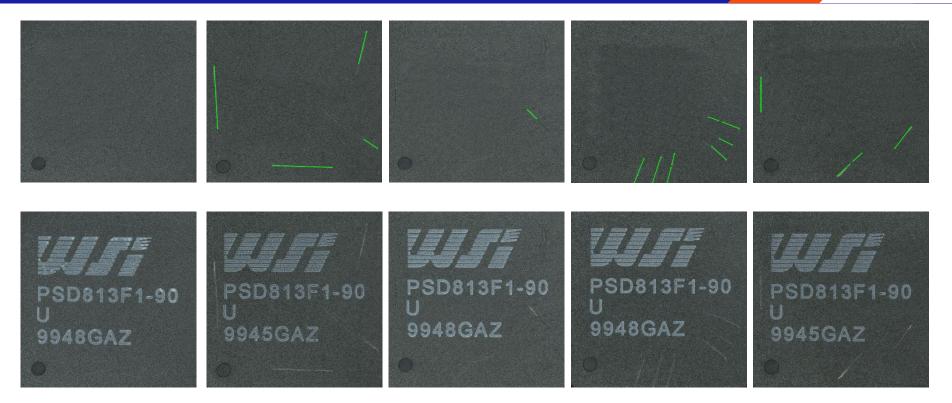
### Results

Average(s)	Standard	1	2	3	4
Detected Scratches	0	4	1	6	3
False Positives	0	0	0	2	1
True Scratches	0	4	8	6	4
Accuracy	100.00	100.00	0.13	0.75	0.60

$Accuracy = \frac{Detected \ Scratches}{True \ Scratches + False \ Positives}$

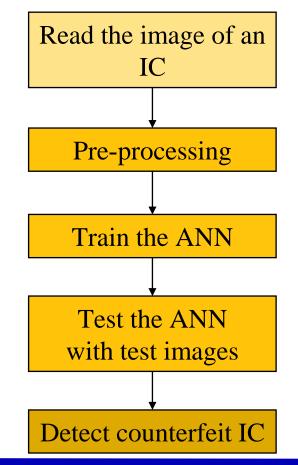
Flowchart for the counterfeit IC detection using neural network

- Information is stored in the interconnections between neurons
- Each neuron in input layer is connected to all neurons in hidden layer.
- Weighted matrix decides the input for each neuron in hidden layer
- Output of a neuron is calculated based on an appropriate activation function (tanh, step function, etc.)
- During training the expected output is compared with the output obtained.
